Transport
Canada

Feedback

Canadian Aviation Service Difficulty Reports

TP 6980E
(6/2011)

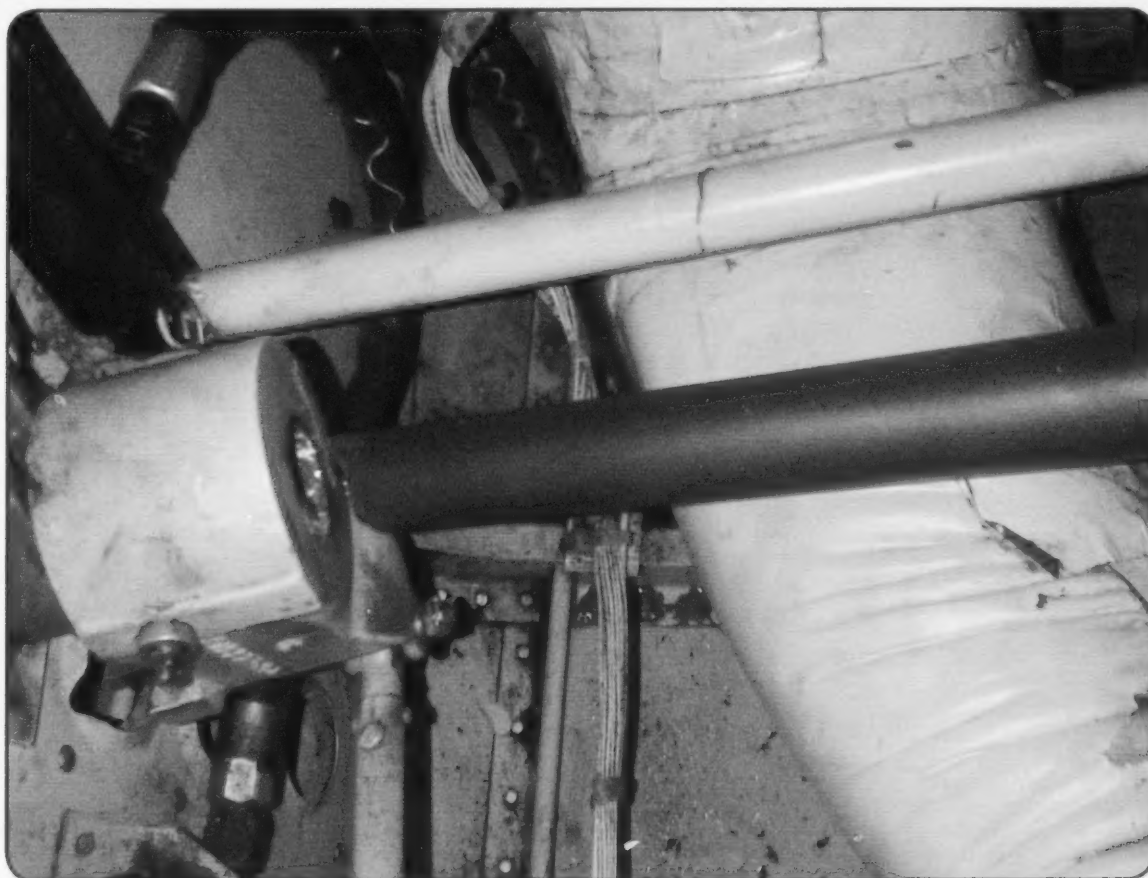
Rudder Torque Tube – Failure

During a functional check, the Aircraft Maintenance Engineer found that the L/H torque tube was broken just inboard of the left rudder pedal block. Disassembly revealed that the rudder torque tube failure started at the taper pin hole that is used to secure the rudder pedal assembly block to the shaft. Further inspection revealed a secondary crack at about 90 degrees. A third crack was found parallel to the initial crack. The failure appears to be from an overload condition.

It is difficult to detect a failure of this type as the initial failure takes place in an area not visible unless the pedal assembly block is dismantled. Once the crack gets large enough to compromise the torsional ability of the shaft, complete failure would likely occur. The entire

rudder and steering system was inspected to determine if other related systems were a factor in this event. No fault found.

Because the pedal block is not disassembled unless necessary, it is recommended that this area be closely examined for defects around the pedal block/torque tube interface. A physical check for any "rotational play" of the torque tube may give an indication of impending failure. ✖

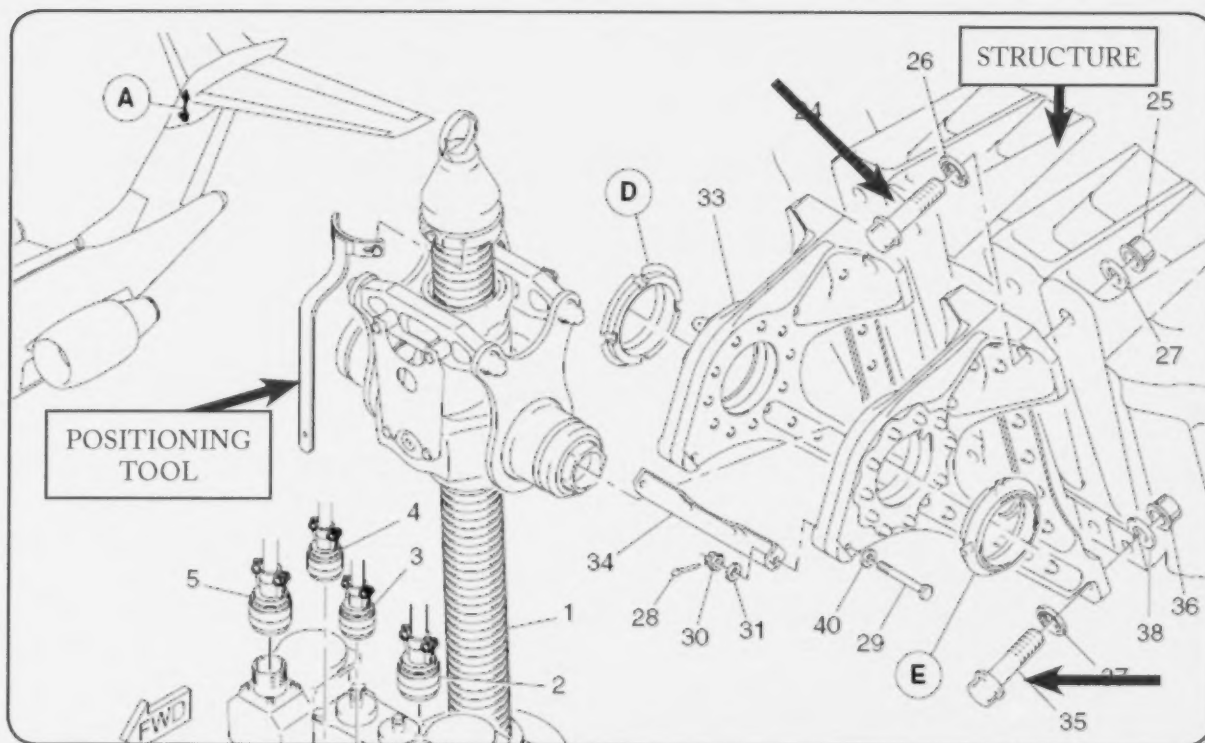
Pitch Trim Actuator - Upper Attachment Loose Bolts

During a routine maintenance check in the translating nut area of the horizontal stab trim actuator (HSTA), two bolts were found loose. These bolts, which are positioned at the upper L/H & lower R/H bolt location, connect the upper half of the pitch trim actuator assembly (Item 33) to the aeroplanes structure. See pictorial below. (Reference CRJ700/900 AMM Figure 27-42-01, Items 24 & 35)

a revision was made to the AMM TR 27-0345 and TR 27-0346 to address the installation of the trim actuator. Manual Change Requirement (MCR) Chapter 20 will now require paint strip marks on the bolt and the nut. The TCH now advises replacement of the nuts after each use.

The 2000 Flight Hour oil level check on the HSTA may be an opportune time to do a precautionary one-time nut torque check. ✕

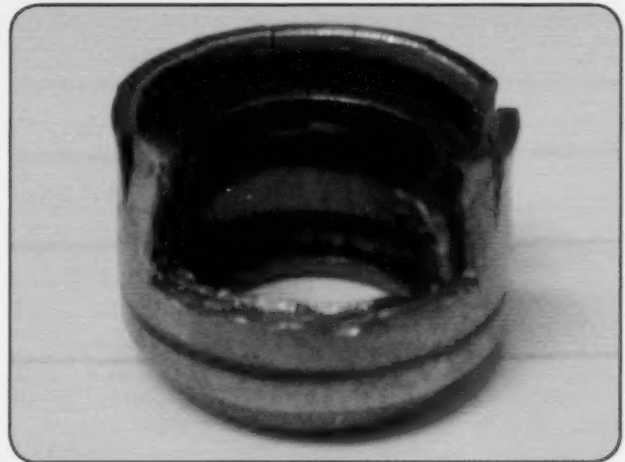
Assymetrical (Split) Flap Condition – Flap Rollers

Shortly after take-off, the R/H flap retract flap cable failed. This was visually confirmed by the pilot. The consequences of the cable failure caused the L/H flap (slave flap) to fall into the fully extended position with the R/H flap (master flap) proceeding to go to the selected flap retracted position. Fortunately, the pilot was able to gain control of the aeroplane.

Initial investigation revealed that the R/H cable was completely severed in the area where the cable rolls over the central flap pulley cluster located in the middle of the cabin behind the headliner (FS 65.33). The subject flap cable was also found frayed in several other areas along the complete flap cable run.

Further inspection found that the L/H aft outboard flap roller (Part Number 0523921) failed due to a "flat spot" on the roller and would not roll thus locking the flap during the retraction cycle. With the slave flap locked in the flap track, the flap motor continued to tension the flap retract cable until the cable failed. The flap motor and transmission can create extremely high torque/tension, which exceeds the tensile strength of the flap cable, if the flap is in a "jammed" condition. The root cause of this event appears to be due to the failure of the flap roller with the flap cable failure as a subsequent event.

Transport Canada Civil Aviation wishes to advise owners/operators to closely inspect the flap rollers for cracks or flat spots. Premature fraying of flap cables may also be an indication of an impending flap roller failure. ✖

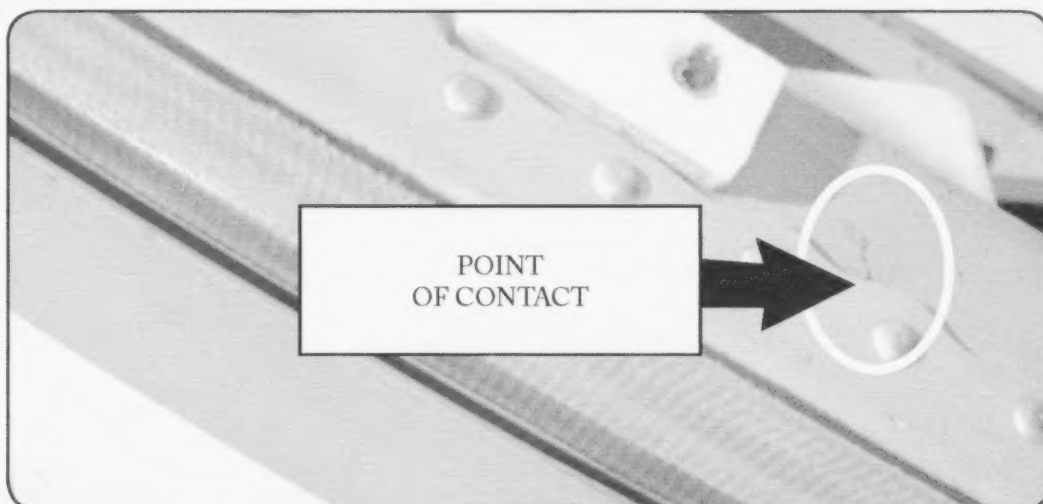
During a standard maintenance visit, the left hand over-wing emergency exit door was found to be obstructed and unable to be opened.

It is unknown as to how long this condition existed or how it occurred.

Transport Canada Civil Aviation would like to emphasize the importance to all maintenance personnel for correct operations of all emergency door exits.

Whenever work is done on or around an emergency exit door, it is essential that an operational test of the door be carried-out to confirm no obstructions exist. ✖

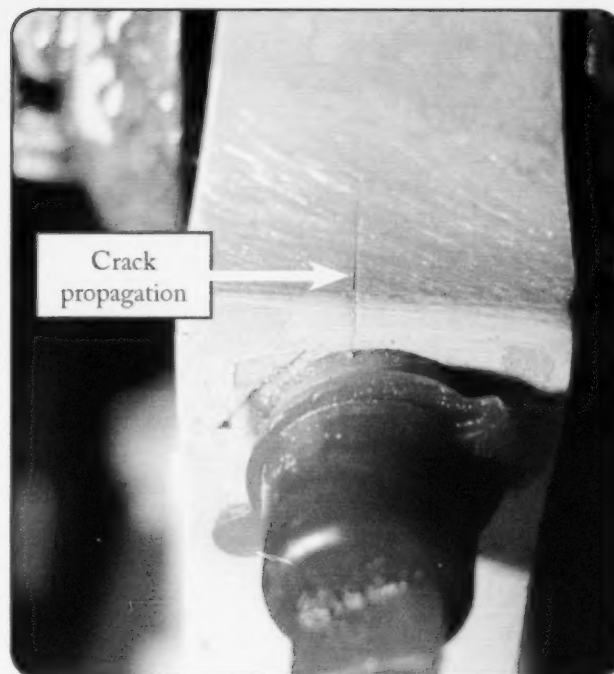
Cracked Nose Landing Gear Bracket

During an inspection of the nose landing gear, a crack was detected extending from the grease nipple on a bracket assembly. The bracket provided the interconnection of the nose gear retraction/extension actuator to the nose landing gear strut assembly.

The Illustrated Parts Catalog (IPC) provides the requirement to upgrade to a different part number replacement bracket where the grease nipple is threaded into the bracket assembly instead of being pressed in, as was the case for the failed part.

The bracket was replaced in accordance with the applicable Aircraft Maintenance Manual (AMM) procedures and the aeroplane was made serviceable.

Transport Canada Civil Aviation would like to advise all operators to be aware of this possible crack propagation scenario and of the available improved replacement part. ✖

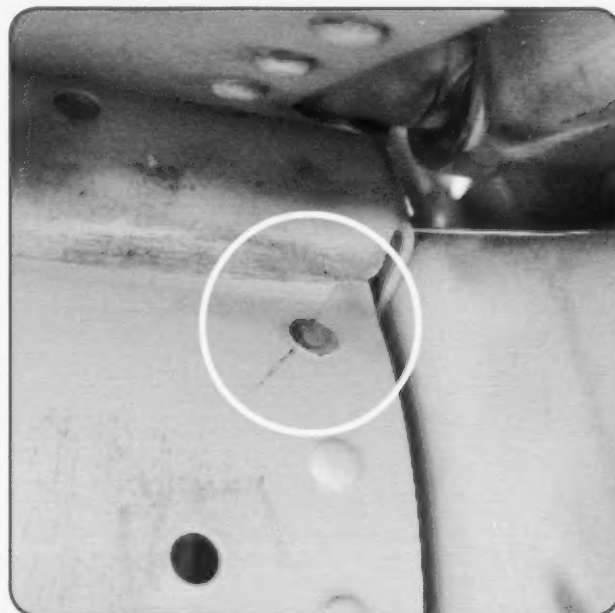
Oil Cooler Door Cracks

During a 100 hour inspection, it was discovered that the Thermostatic Oil Cooler Door Panel was cracked on both ends including a sheared rivet on the R/H end.

The cause of the failures is presently unknown but it is suspected that it may be due to a lack of material robustness.

Transport Canada Civil Aviation would like to advise all operators of this possible condition. ✖

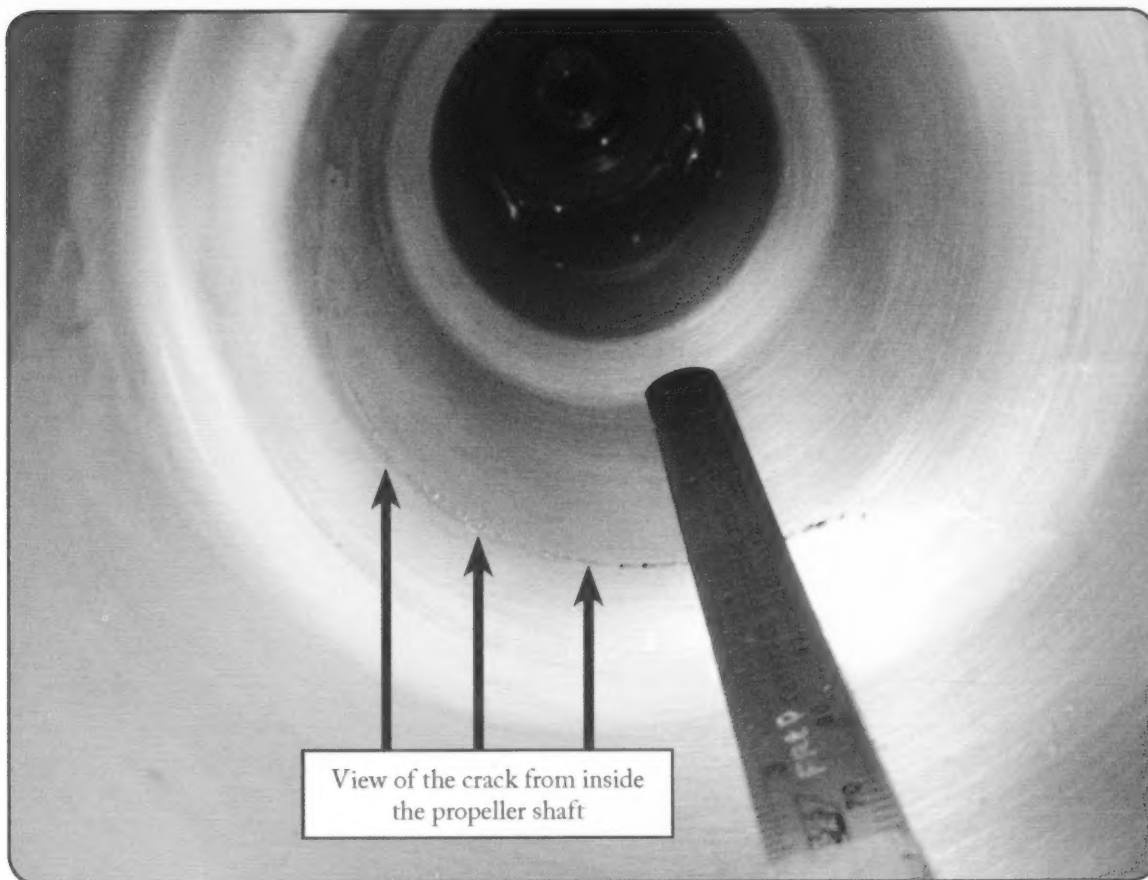
Engine Propeller Shaft Crack

During a pre-flight walk around, the pilot noticed an external oil leak from the propeller shaft area. A more detailed inspection revealed a crack almost half way around the circumference of the shaft at approximately 10 to 11.5 cm (4 to 4.5 inches) from the front flange.

visual inspection and metal testing have confirmed that the crack was caused by hydrogen embrittlement.

The engine was removed and replaced and the aeroplane was made serviceable.

PWC are progressing with a more in-depth investigation and have issued Service Information Letter PW100-139 as well as Service Bulletin 21798 advising all PW100 Series engine operators of this possible scenario.

Transport Canada Civil Aviation would like to emphasize to all affected operators the importance for thorough flight crew and maintenance awareness when addressing propeller shaft oil leaks. ✖
